THE GEOLOGICAL SURVEY OF WYOMING  
S.H. Knight, State Geologist  
University of Wyoming  
Laramie, Wyoming

GEOLOGY OF THE LA PRELE DAM SITE, CONVERSE COUNTY, WYOMING

The geology of the dam site was examined and mapped by Horace D. Thomas and Joseph Neely on August 26 and 27, 1936, in an attempt to correlate water losses from the reservoir with the geologic setting of the dam. Mr. Oliver Roush, of Douglas, spent both days at the dam and his assistance greatly facilitated the field work.

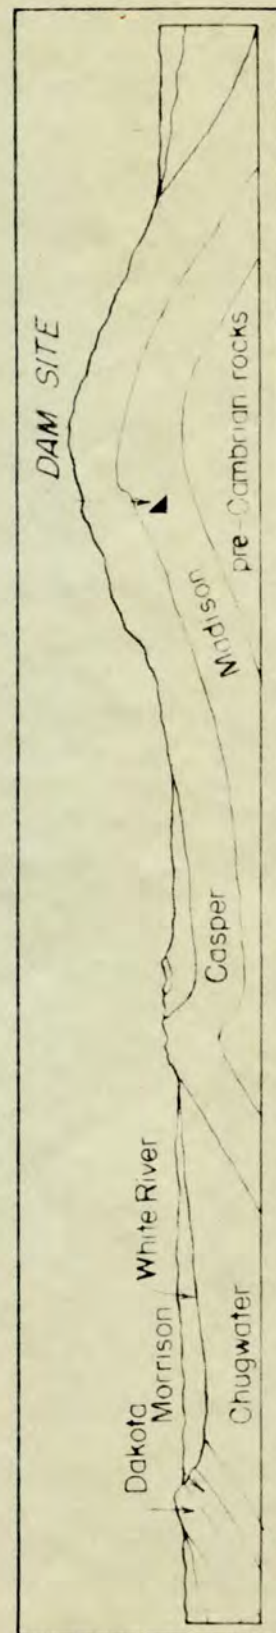
Fig. 1 - Diagrammatic geologic cross-section along La Prele Creek showing the position of the La Prele dam.

Geologic Structure.- The region southward from the Platte River to a point about a mile north of the dam site is covered by a mantle of horizontal Oligocene rocks (White River) which rests unconformably upon the beveled edges of the folded Mesozoic rocks (Fig. 1). Several miles north of the dam site, sandstones of the Dakota group dip north and form an east-west trending ridge of low relief which protrudes from the surrounding Oligocene rocks. At the Natural Bridge, about a mile north of the dam site,

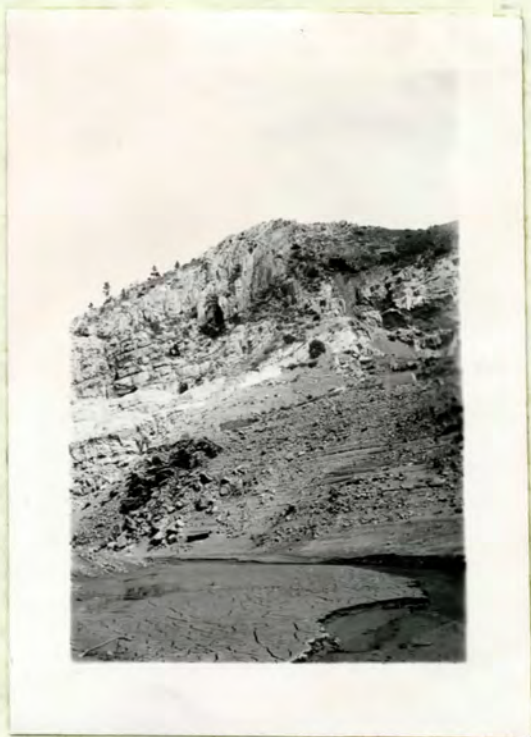
high water line, in the east wall of the canyon, and a short distance upstream from the dam, these limestones are warped upward abruptly into an overturned minor anticline (Fig. 2). The fold is overturned to the north and appears to have broken, so that it is, in reality, an incipient thrust fault. However, the fold is not discernable in the west wall of the canyon.

The result of this sharp fold has been an intensive fracturing of the brittle limestones below it at the dam site. At point "C" on the accompanying map, the lavender limestone member and the gray massive limestone member of the Madison are cut by a set of fractures which trend N. 80° W., and which stand essentially vertical. That there has been actual horizontal movement along these fractures is shown by the slickensided nature of the chert nodules in the lavender member. Solution cavities have formed along fracture planes. The fractures are sometimes open due to weathering, and the fractures are generally lined with vein deposits of crystalline calcite.

- Fig. 2 - View of the east canyon wall a short distance upstream from the dam site showing the sharp flexure in which the limestones are warped into a vertical position.
- Fig. 3 - Madison limestone in the east abutment of the dam. Vertical fractures and bedding planes are here opened by weathering.
- Fig. 4 - View from top of dam, looking downstream, showing the dip of the beds in that direction. Numerous seeps arise from the lavender limestone member shown in the lower left-hand corner of the photograph.
- Fig. 5 - View of the face of the dam and the east abutment. The lavender limestone from which seeps arise downstream from the dam is shown in the lower part of the canyon wall.

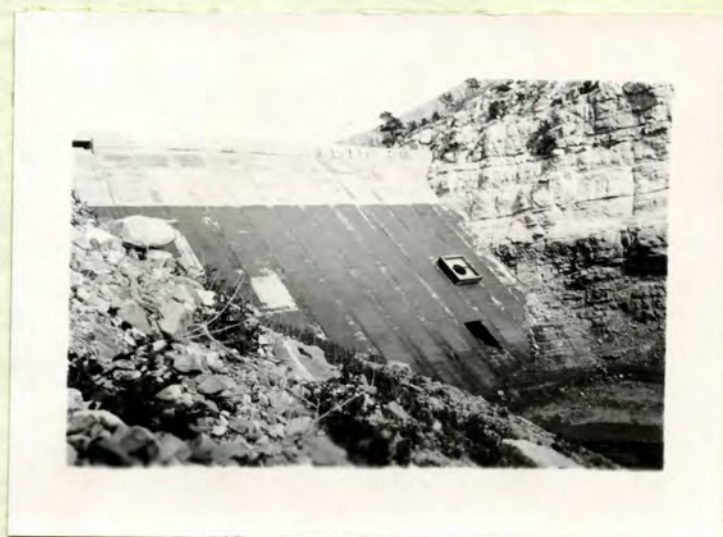
Fig. 5

The positions of these seeps are shown on the map, and all arise from the lavender limestone. The seeps on the west side of the creek, east of point "E", arise from vertical fractures which cut the limestone. The seeps on the east side of the canyon are not so well defined, but are located on the same limestone. The water probably seeps from both fractures and bedding planes. A seep under the dam also arises from this same limestone member.

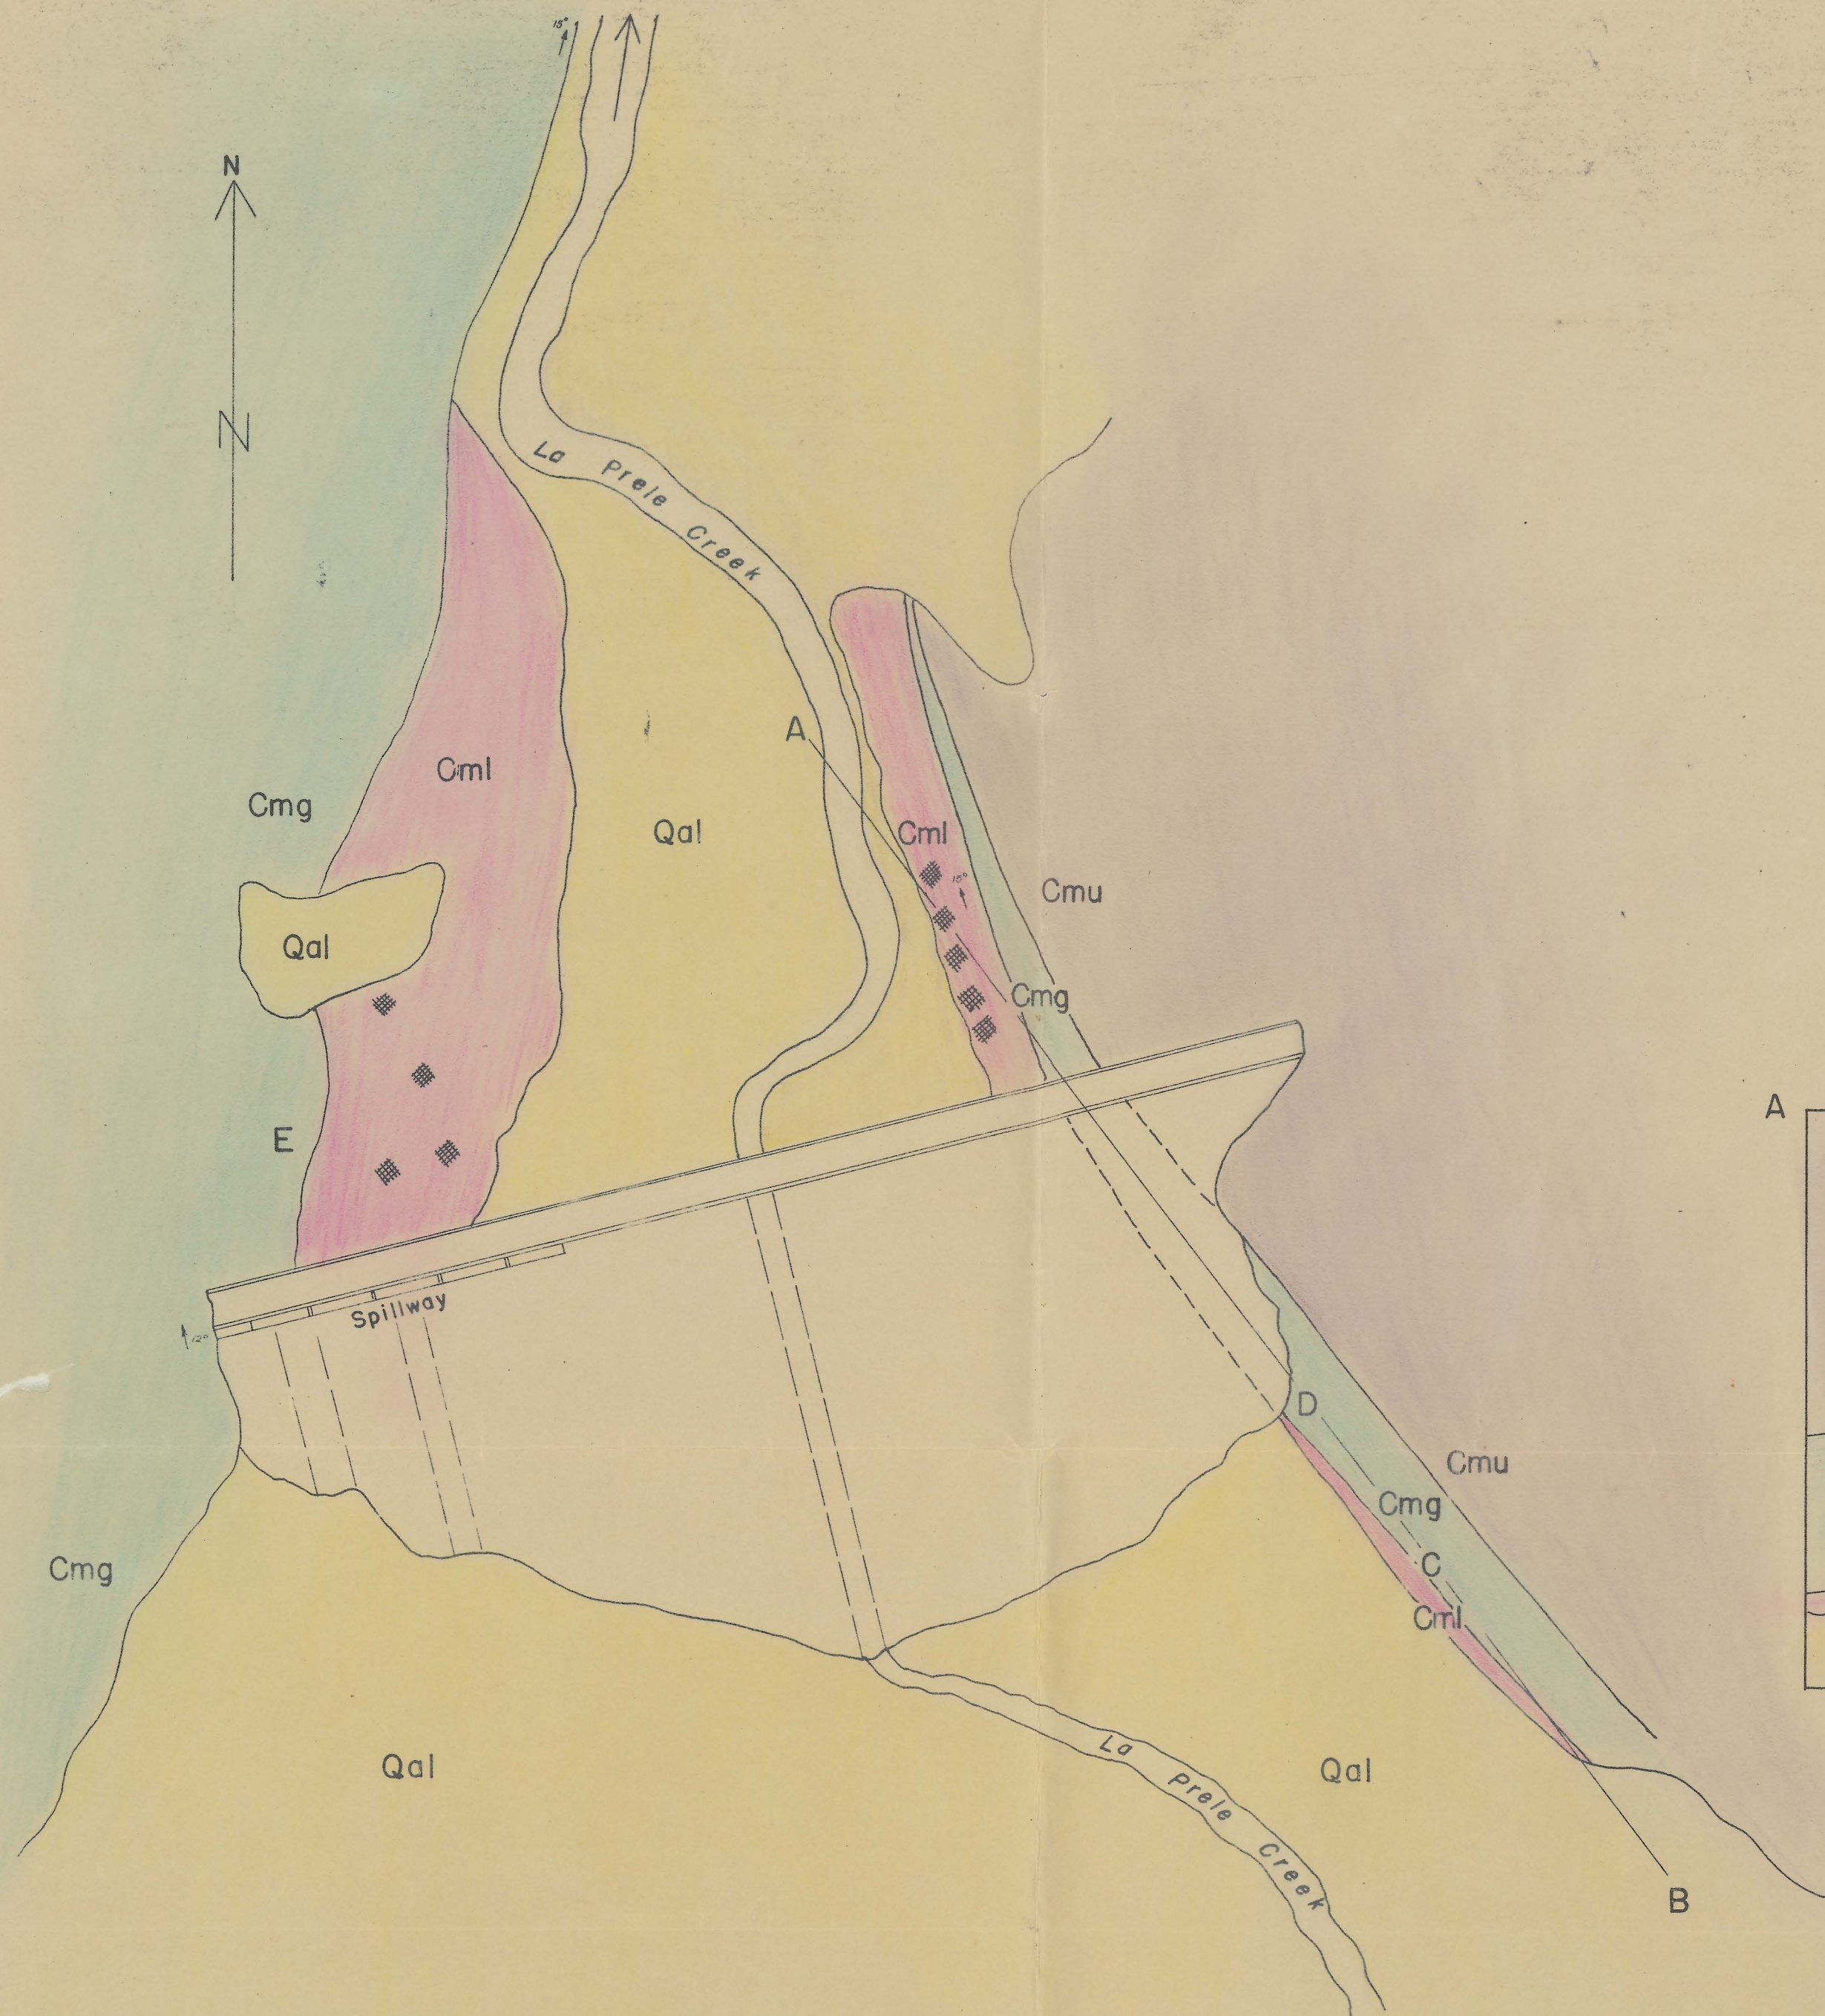
GEOLOGIC MAP  
of the  
LA PRELE DAM SITE

On the downstream side of the dam on the west side of the creek, near point "E", the lavender limestone member is strongly jointed by north-south and east-west fractures, and in places is irregularly broken. Certain beds show many slickensided surfaces which have an east-west trend and which dip from 10° to 30° to the south. The overlying gray massive limestone on this side of the canyon is highly brecciated and is cut by innumerable calcite-lined fractures.

indicates the deposition of lime along these openings by percolating water. At point "D" on the map is an open cavern, about 2 feet by 1 foot, in the gray massive limestone which connects downward with a calcite-lined fracture. At point "E" on the map is a large solution cavern located in a highly fractured area in the same limestone member. Solution by percolating water has opened cavities along many of the bedding planes in the lavender limestone member. The caverns, then, are features of solution and the calcite veins are features of deposition brought about through the agency of percolating water.

Inasmuch as the water enters the limestone through innumerable openings, the only means of stopping the seepage would be to cover the outcrops of the beds on the canyon walls upstream to a point where the dip brings them above water level. The method of blocking off these outcrops lies beyond the scope of this report.

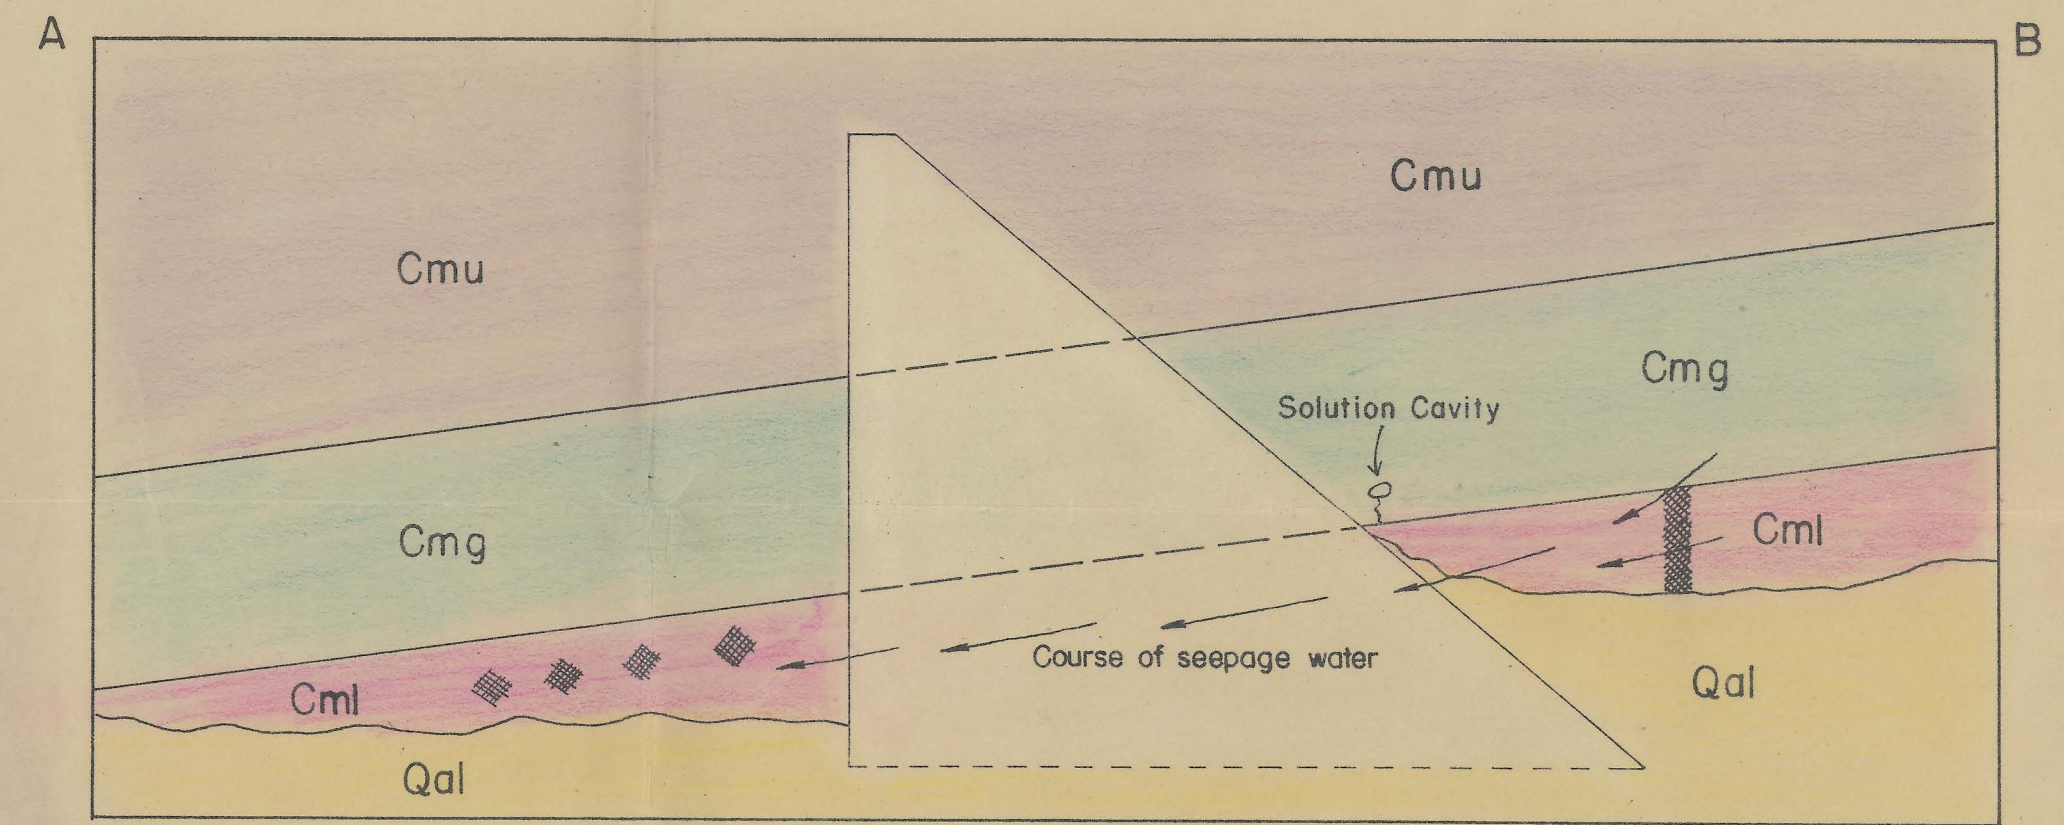
Diagram Showing Relationship of Dam to Bedrock Along Line A-B  
Elevations of Contacts Projected

4.- The beds in which the seeps occur on the downstream side of the dam dip gently upward through the dam site and crop out below the water level on the upstream side of the dam.

5.- From these facts it is concluded that water enters the outcrops of the limestones in the reservoir, follows down the dip of the beds through fractures and along bedding planes, passes around the dam through the canyon walls, and arises as seeps on the downstream side of the dam. Probably not all the water which enters the beds comes out in seeps, for some possibly continues down the dip.
