RENNER (MEADOWS) DAMSITE, PARK COUNTY

Location: Sec. 15, T. 32 N., R. 102 W.

Date Examined: October 3, 1957

Storage: A dam approximately 115 feet high will impound 16,000 acre-feet of water.

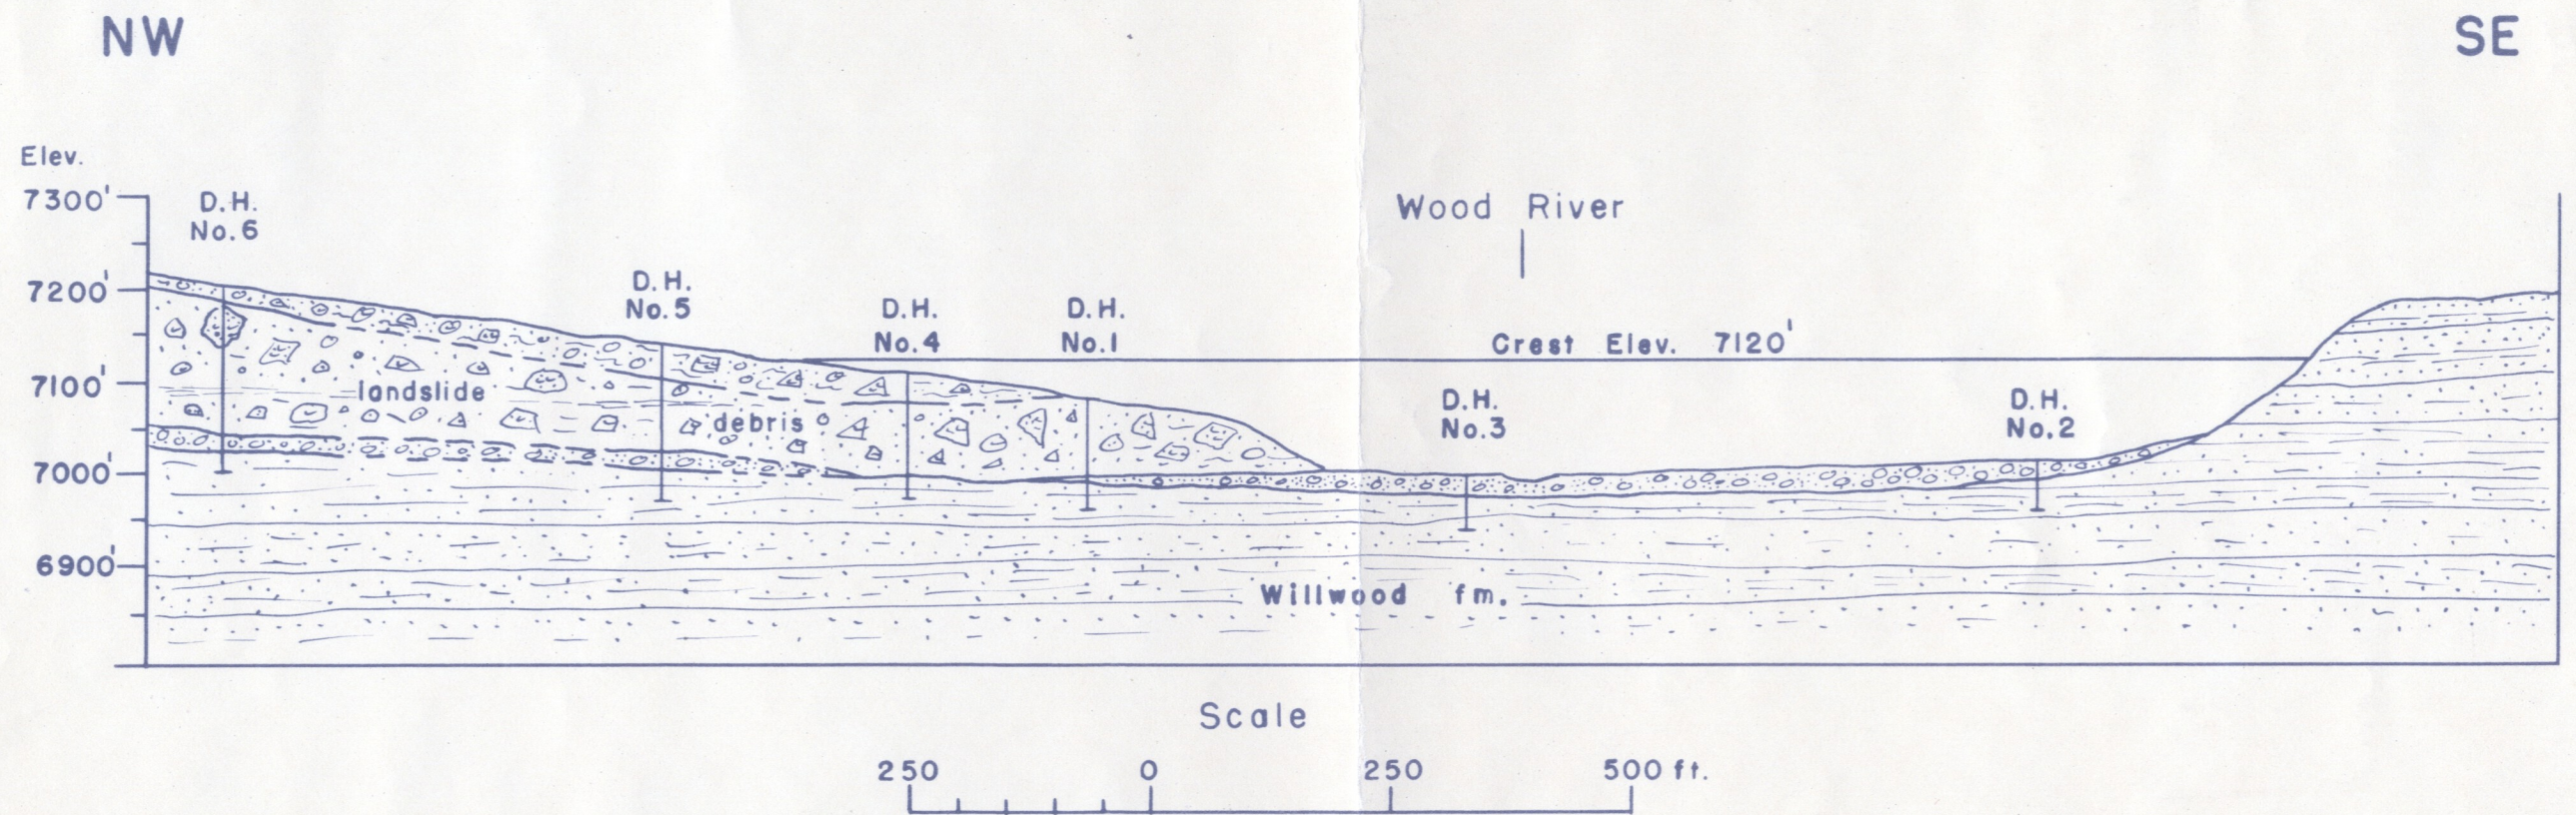
NORTHWEST - SOUTHEAST GEOLOGICAL CROSS SECTION
 (along axis of dam)

At the damsite the landslide debris overlies a thin unit composed of sand and gravel; evidently a former channel of Wood River. The slide as a whole lies on the Willwood formation (see enclosed geological cross section).

The depth to bedrock (Willwood formation) in the Wood River channel as indicated by U. S. Bureau of Reclamation drill holes varies from 20 to 30 feet.
