REPORT ON ANALYSIS OF POTENTIAL FOR RELATIONSHIP BETWEEN THE CONSOLIDATED OIL AND GAS COMPANY HERREN GULCH #2 WELL AND ALKALI AND BOG CONDITIONS AT THE DAVIS RANCH NEAR GREYBULL, WYOMING

By James C. Case, Geological Hazards Geologist, Geological Survey of Wyoming

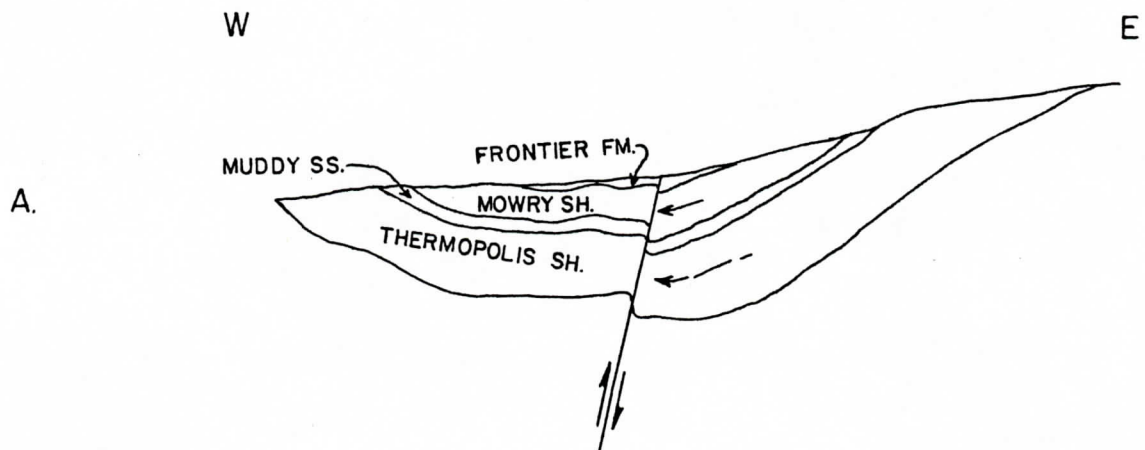
Inferred flow of ground water with reverse fault present as indicated on Geomax cross section.

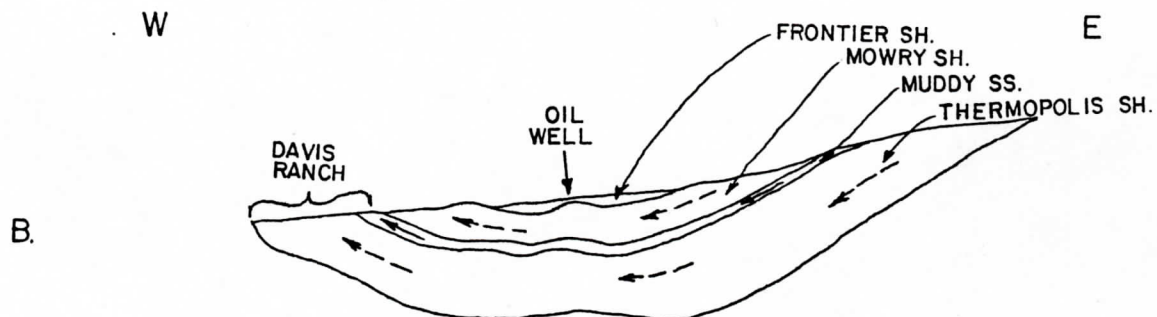
If the reverse fault shown on the Geomax cross section is not present, the regional hydrologic scenario would be markedly different. Figure B (page 5) is an idealized diagram that shows how ground water could flow and discharge with the inferred reverse fault not present. There would be a tendency for any of the geologic units exposed in the vicinity of the Davis Ranch to discharge water if they were permeable enough to transmit it.

Unless new data are made available, I feel that the scenario shown in Figure B is the most likely for the area. In other words, with the data we have available, I do not feel that the well has to be leaking in order for seeps to appear in the Davis Ranch vicinity. By the same token, I do not have strong evidence that the well is absolutely not leaking and having some effect on the Davis Ranch, although the alkali problem appears to have been present long before the well was drilled, as mentioned earlier. In my opinion, the only definite way to tell whether or not the well is leaking is to open it up. If the water in the well is not leaking past any of the plugs present, the question is answered. If leakage is occurring, the well should be re-plugged. If the well is shown to be leaking, that still does not prove that it was having an effect on the Davis Ranch. In my opinion, a monitoring program would have to be established to define current conditions at the ranch, as well as to document diminishing adverse effects after the well is re-plugged.

Inferred flow of ground water with reverse fault not present.
