Preliminary report on the proposed Little Sandstone Reservoir Site

James C. Case and Alan J. VerPloeg

GEOLOGIC HAZARDS IN THE VICINITY OF THE PROPOSED LITTLE SANDSTONE RESERVOIR
BY JAMES C CASE AND ALAN J VerPLOEG

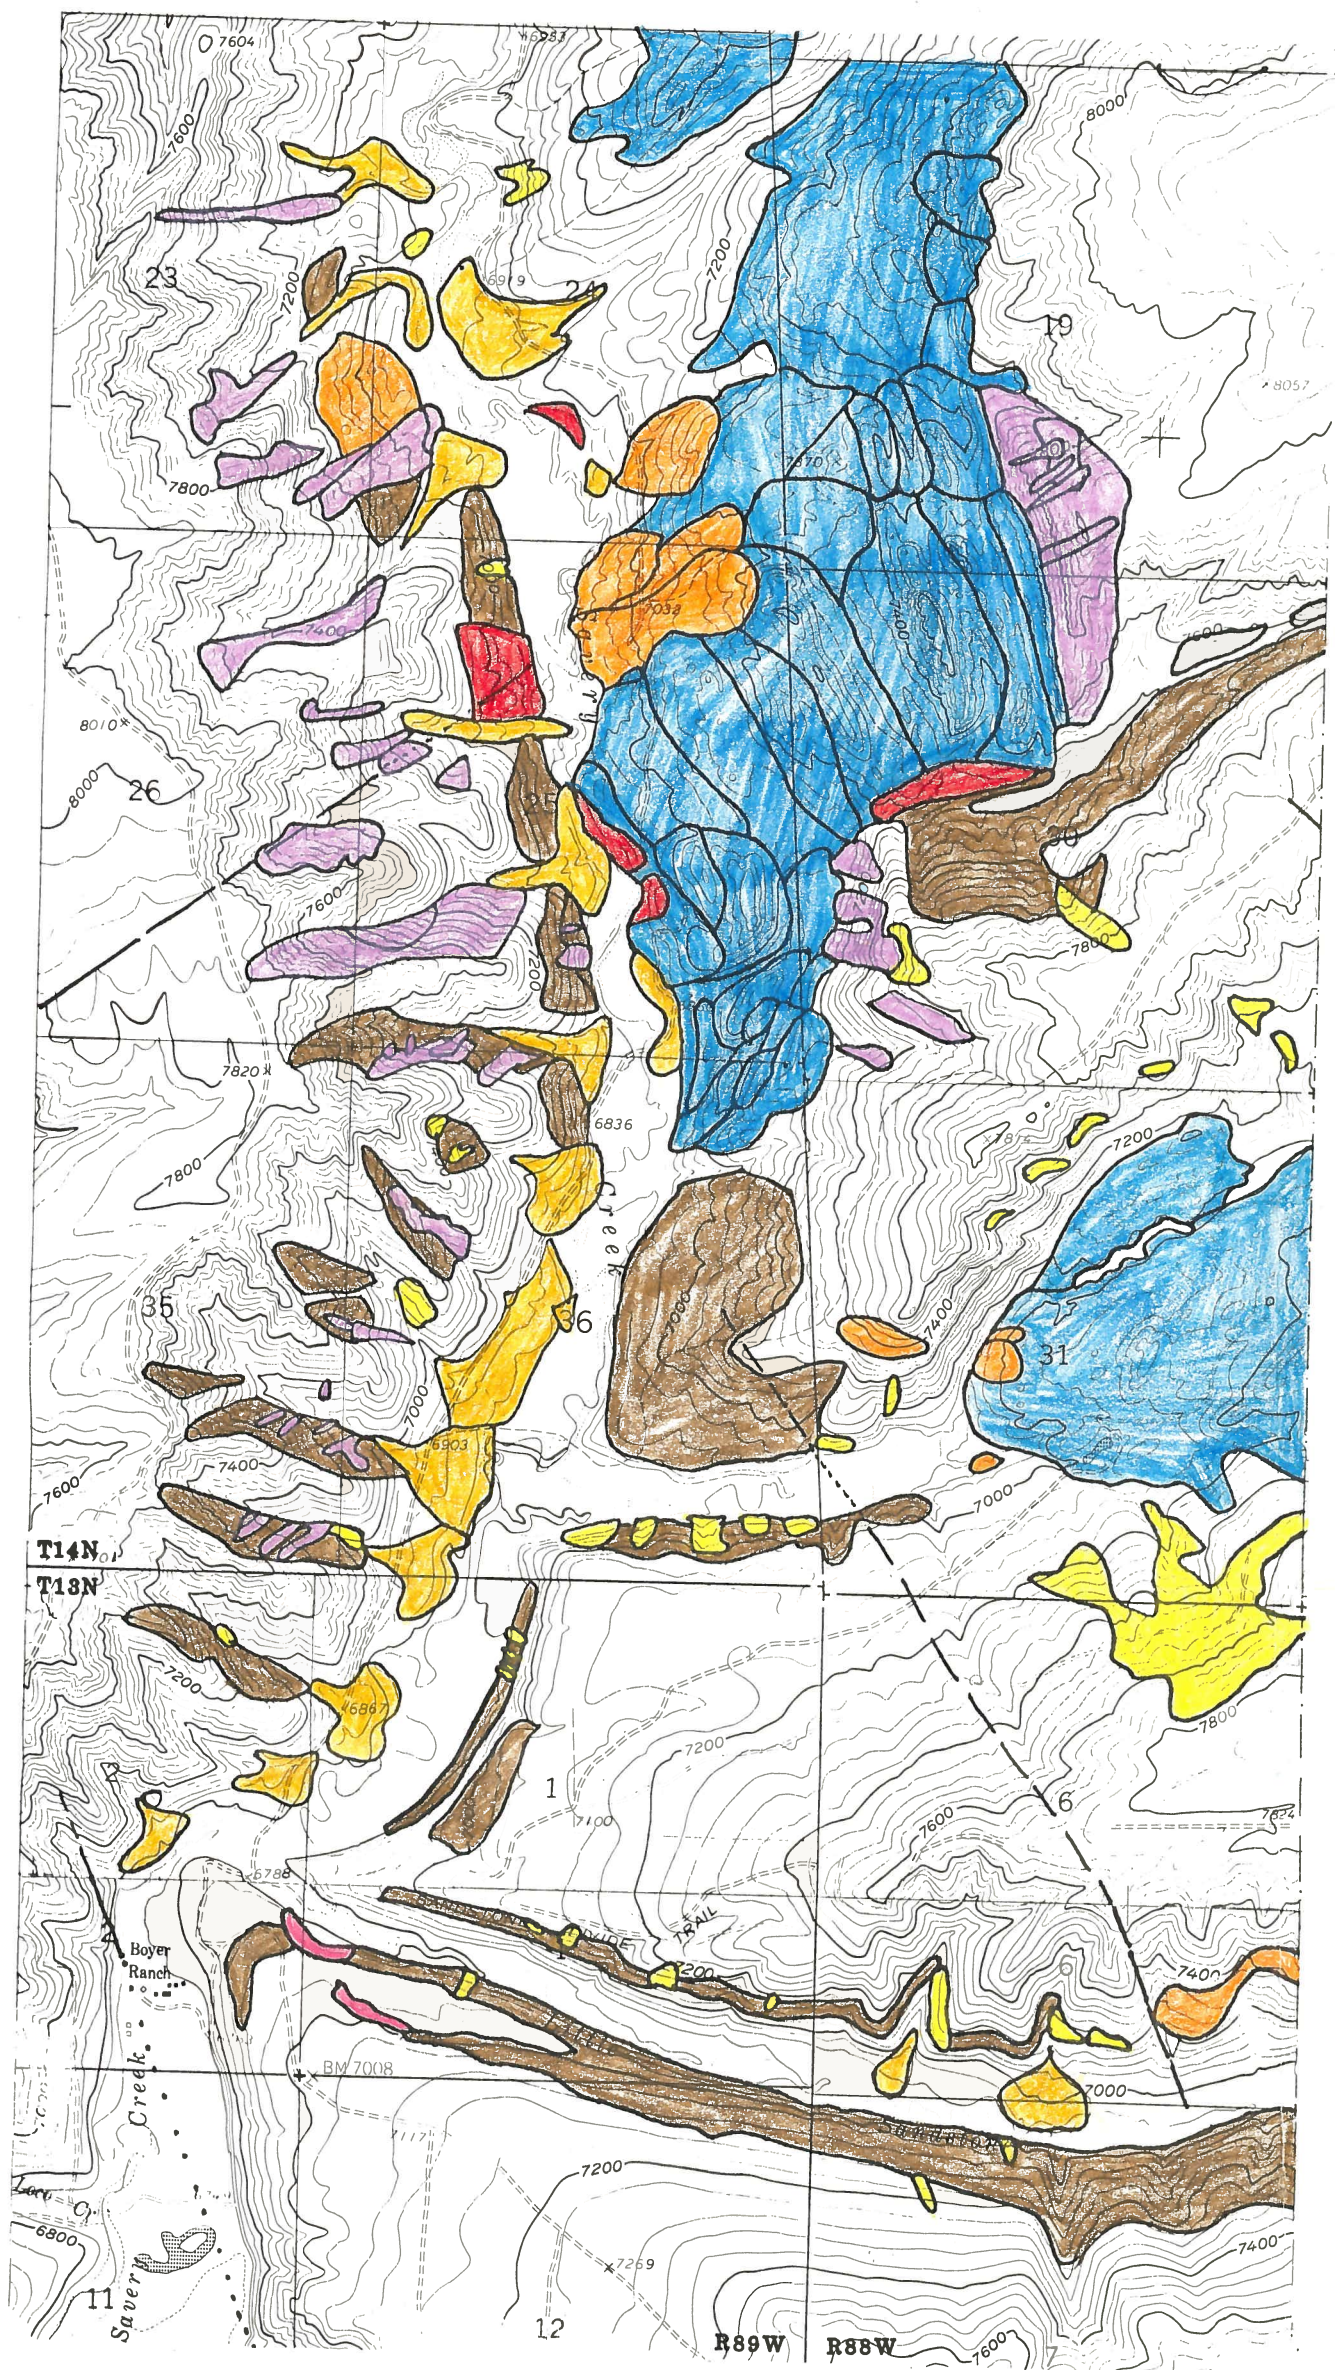
There are two major rock block slide-block glide complexes in the study area. They are relatively deep seated, composed of bedrock and cover large areas (see enclosed map). These large block slides and glides found in the area are of the type that are generally slow moving. A rapid catastrophic movement would be very unusual as both complexes are already encroaching on the opposite valley walls. If they destabilized suddenly, they could not move any appreciable distance.

The large block slide complex along Savery Creek does have other slope movements associated with it that may react more quickly to increased saturation. As can be seen on the enclosed map, there are a few sizable slump-flows (probably debris laden earthflows) that have formed from both the rubble derived from the block slides and from the block slides themselves. If those flows were

There are numerous zones of talus or weathered bedrock that have destabilized in the form of flows, slumps or slump-flows. Most of the movements are shallow and should not be directly affected by the reservoir. However, they will be a continuing source of sediment. As can be seen on the enclosed map, many of the talus and weathered bedrock movements are on north-facing slopes.

In summary, there are many slope movements and slope movement types in the study area. Existing movements as well as areas that may be prone to certain types of movement have been delineated on the enclosed map. Much of the interpretation has come from analysis of aerial photography. Classifications and locations may change when the whole area is examined on the ground.

Close examination of the east abutment revealed no obvious slump scarps although one area was flagged as having a potential for small scale shallow slumps. That area is delineated on the enclosed map. There was only marginal evidence for what could be construed as a highly weathered small scale slump in that area.

As a suggestion, if the proposed high water line is plotted on the enclosed map of geologic hazards, areas that will be saturated or subjected to fluctuating water levels can be delineated. Various types of worse case scenarios can then be generated. The scenarios can be created for various depths of material that will move into the reservoir and various periods of time over
