GEOLOGIC REPORT ON THE UPPER SUNSHINE BASIN DAM SITE, PARK COUNTY, WYOMING

S.H. Knight, R.H. Beckwith, J.D. Love, and G.L. Hurwitz

1935

OPEN FILE REPORT 35-2

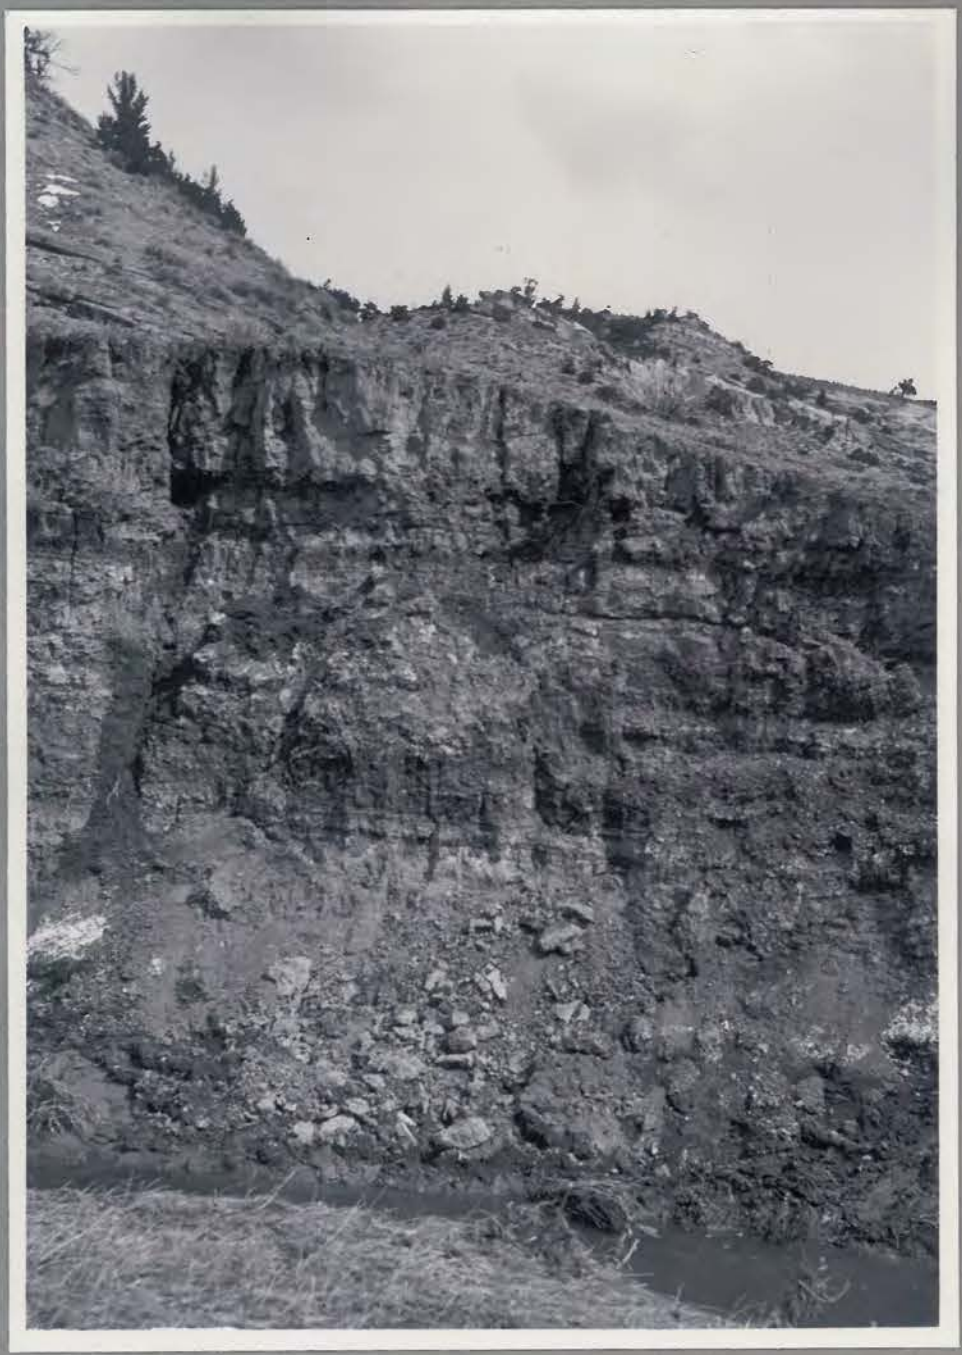
Plate III. General view of the Sunshine dam and reservoir sites looking west upstream.

Plate IV. The divide and gulch north of the Sunshine dam site. The left end of this photograph overlaps the right end of Pl. III.
